Issue: Temperature/Humidity sensor # added or removed

Product line: ACDA901

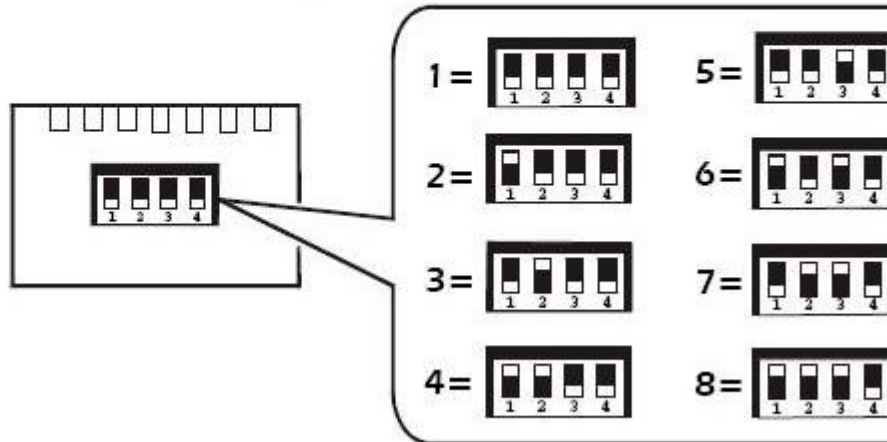
Set the A-Link address

Resolution: This alarm occurs every time you add or remove a AP9520TH sensor on the a-link bus. Also you can get a removed alar if the sensor fails or the connection is disconnected.

Set the DIP switches on each sensor to a unique A-Link address.
