Issue: Temperature/Humidity sensor # added or removed

Product line: ACDA901

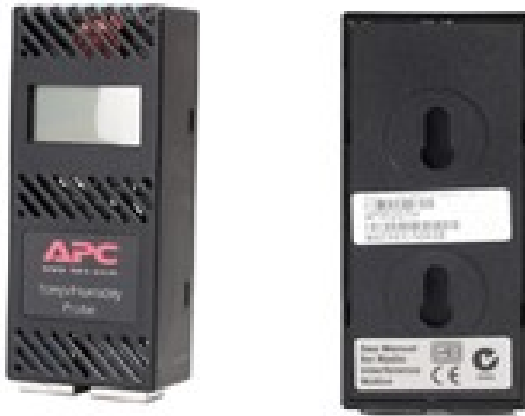
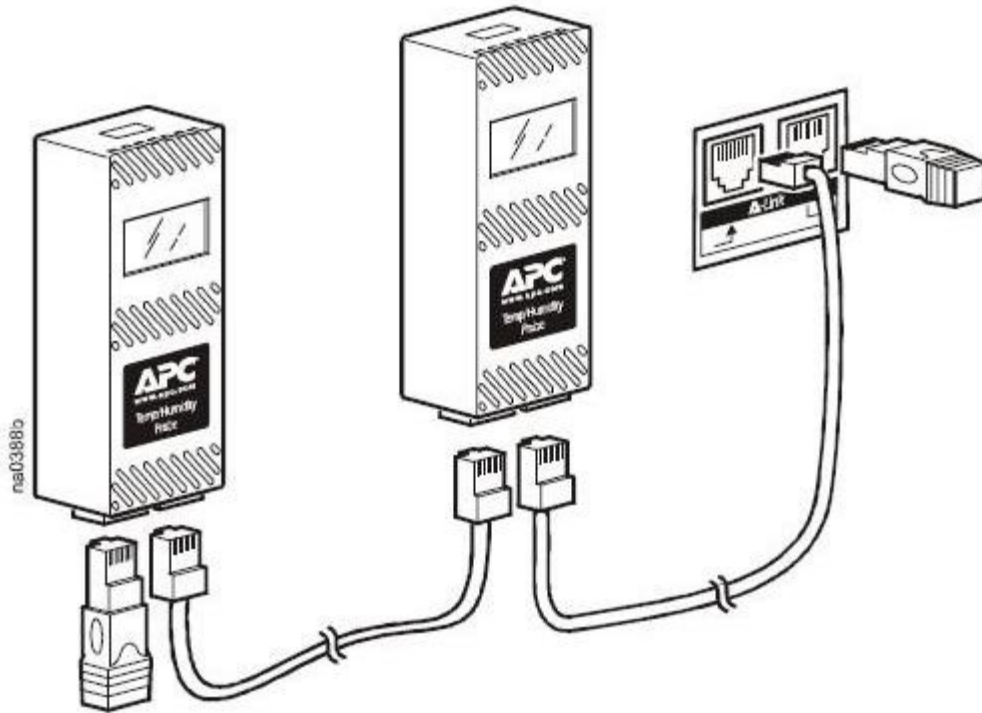
Set the A-Link address

Cause: An AP9520TH sensor has been detected. An AP9520TH sensor has been removed.

Resolution: This alarm occurs every time you add or remove a AP9520TH sensor on the a-link bus. Also you can get a removed alar if the sensor fails or the connection is disconnected.

Set the DIP switches on each sensor to a unique A-Link address.
