Multi-Loader - Firmware update

Update ATV12 / ATV32

Version 2

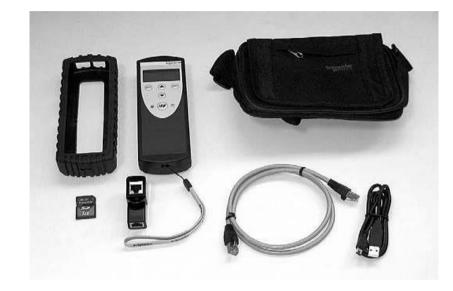
• VW3 A8 121

• VW3 A8 122 (specific cable)
